The evaluation of suitability for operation of repair low-alloy steel welded joints

Purpose: The purpose of the work was to evaluate the material condition of repair welded joints of steam pipelines with regard to their suitability for operation including determination of the time of their further safe operation.

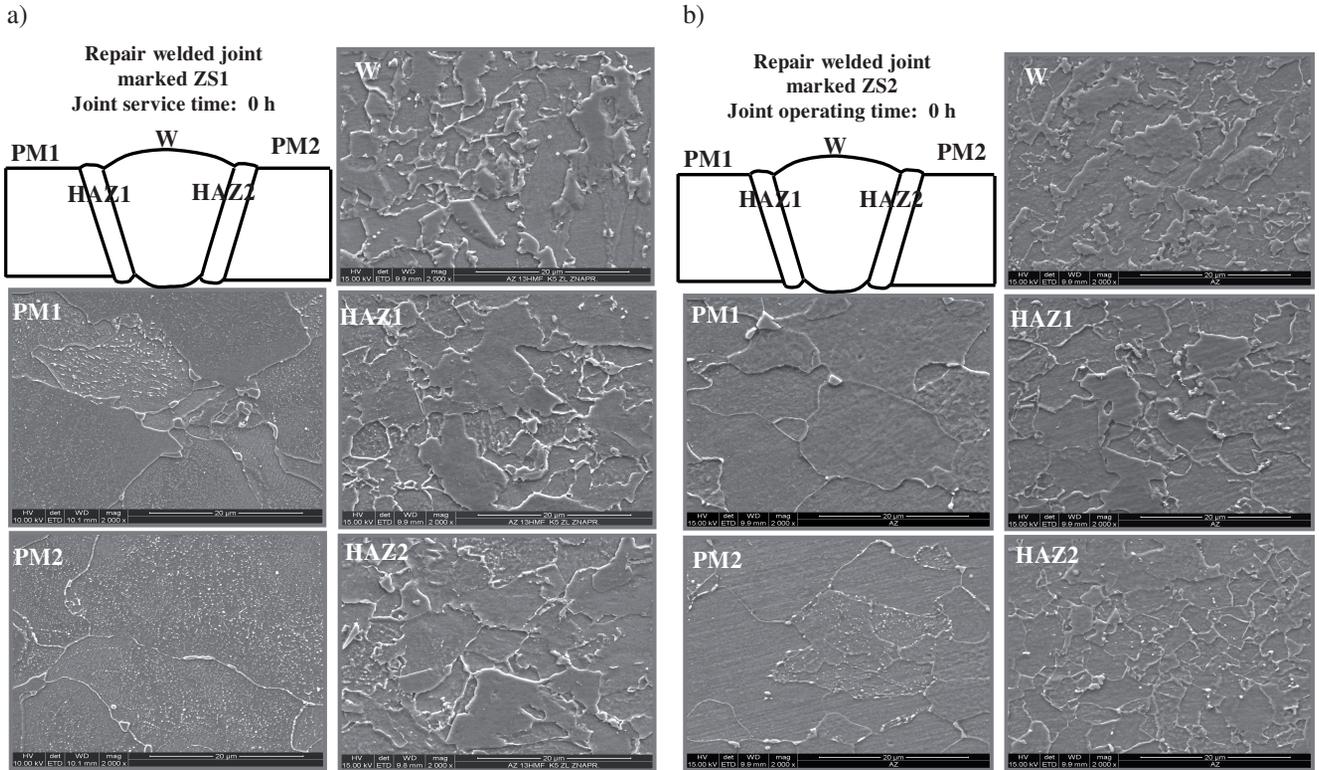
Fig. 2. Microstructure of the material of elements of the examined new repair welded joints. Area of microstructure investigations: parent material marked MR1, MR2; weld metal marked SP; heat-affected zone marked HAZ1, HAZ2

Material for investigations	Description of microstructure Material condition – exhaustion degree	Hardness HV10
New repair welded joint of the primary steam pipeline Grade: 14MoV6-3 (13HMF) Service time: 0h marked ZS1	PM1/PM2 Ferritic-bainitic structure. Partially coagulated bainitic areas. At the ferrite grain boundaries, there are precipitates of different size, mostly fine. Inside the ferrite grains, there are very fine evenly distributed precipitates. No discontinuities and micro-cracks are observed in the structure. No initiation of damaging processes is observed. Bainitic areas: class I, precipitates: class a <u>Damaging processes: class O</u> CLASS 1/2, EXHAUSTION DEGREE: approx. 0.3	157
	HAZ1/HAZ2 Heat-affected zone structure. No discontinuities and micro-cracks are observed in the structure.	297/ 309
	W Structure of weld material in welded joint. No discontinuities and micro-cracks are observed in the structure.	250

PM1 Ferritic-bainitic structure. Partially coagulated bainitic areas. Numerous precipitates of various sizes at the ferrite grain boundaries. Numerous fine or small precipitates inside the ferrite grains, distributed rather evenly. No discontinuities and micro-cracks are observed in the structure. No initiation of damaging processes is observed. Bainitic areas: class I, precipitates: class a/b <u>Damaging processes: class O</u> CLASS 2, EXHAUSTION DEGREE: approx. 0.3-0.4	146
New repair welded joint of the primary steam pipeline Grade: 14MoV6-3 (13HMF) Service time: 0h marked ZS2	PM2 Ferritic-bainitic structure. Microstructure characteristic of the examined steel in the as-received condition. No discontinuities and micro-cracks are observed in the structure. Bainitic areas: class 0, precipitates: class o; <u>Damaging processes: class O</u> CLASS 0, EXHAUSTION DEGREE: 0	155
	HAZ1/HAZ2 Heat-affected zone structure. No discontinuities and micro-cracks are observed in the structure.	262/ 279

W Structure of weld material in welded joint. No discontinuities and micro-cracks are observed in the structure.	229

The structure of the examined materials consists of ferrite with bainite. The examined selected materials differ in the form of bainite and the state of development of carbide precipitation processes. In accordance with the Institute for Ferrous Metallurgy's own classification, the ZS1 joint material is characterised by material condition corresponding to class 1/2 with exhaustion degree of approx. 0.3 (Table 2). The condition of the ZS2 joint material after service corresponds to class 2 with exhaustion degree of 0.3-0.4 (Table 2), while the ZS2 joint material in the as-received condition characterised by class 0 with exhaustion degree of 0. Moreover, the structure of the welds and heat affected zones showed no initiation of the internal damaging processes (damage class 0).

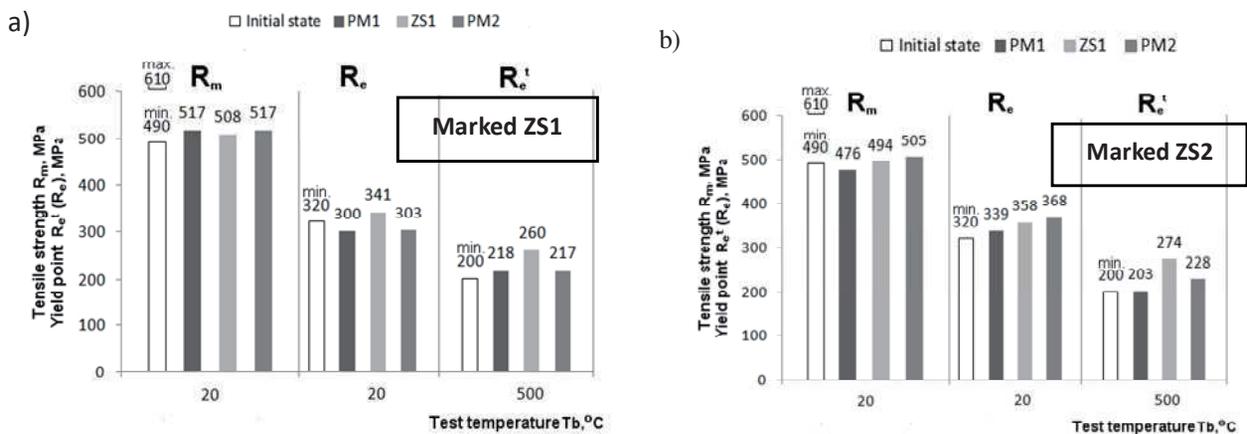
Fig. 3. Results of investigations on mechanical properties of the materials of examined elements of new repair welded joints in the primary steam pipeline specimens, in particular: tensile strength and yield point at room and elevated temperature

Regardless of the structure class of the parent material as well as the heat affected zone and weld metal for the repair welded joint marked ZS1 at room temperature, the tensile strength level is higher and the yield point level is lower for the parent material and higher for the welded joint than the required minimum values for the base material in the as-received condition (Fig. 3).

For the repair welded joint marked ZS2, the requirement for tensile strength and yield point at room temperature is satisfied, with the exception of the parent material after service for which the tensile strength is lower than the minimum required value for the base material (Fig. 3).

The obtained results for yield point at 500°C of both the examined new repair welded joints are higher than the minimum required values for the base material in case of both the parent material and the welded joint (Fig. 3).

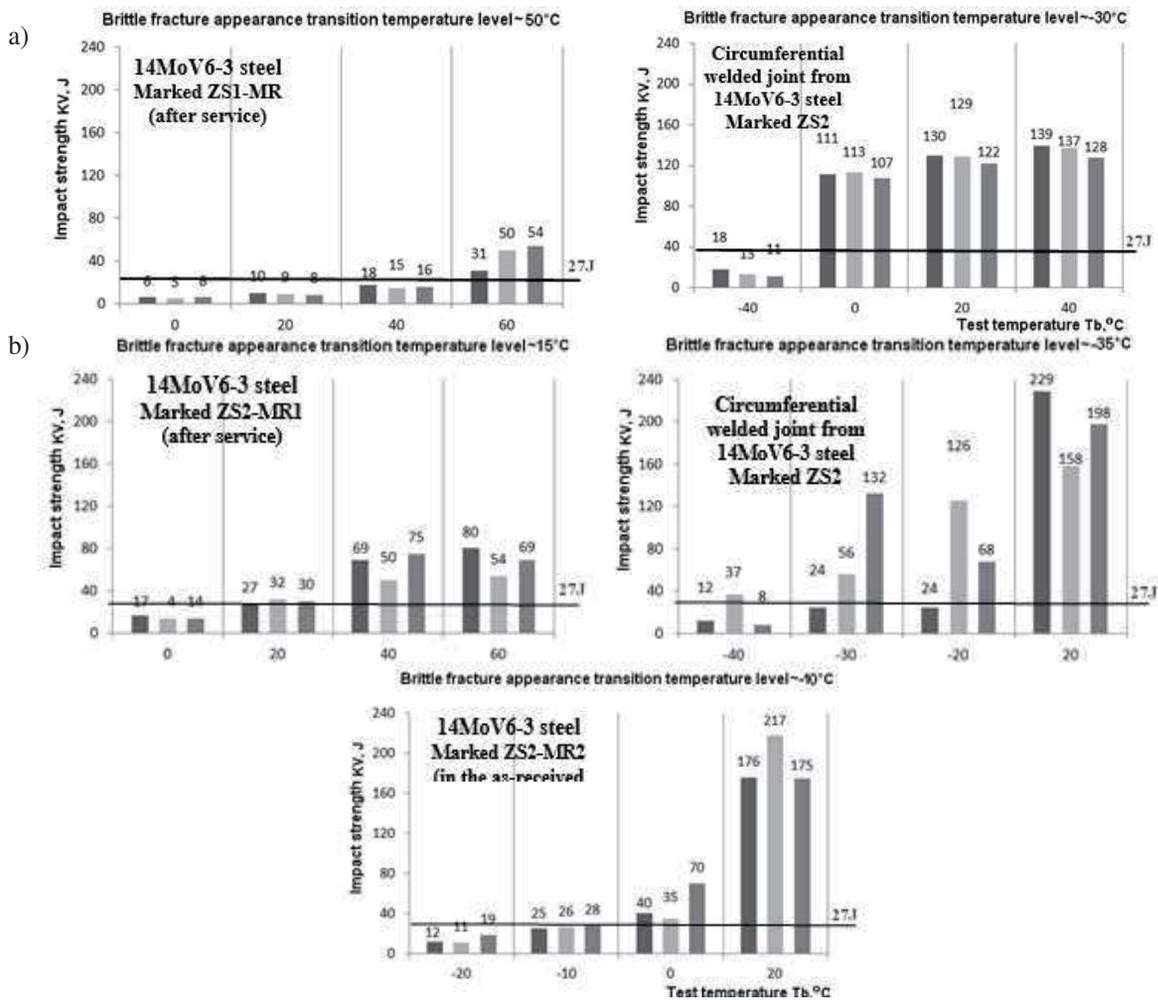
Fig. 4. Results of investigations on mechanical properties of the materials of examined elements of new repair welded joints in the primary steam pipeline specimens, in particular impact energy at various test temperature levels, for: a) new repair welded joint marked ZS1; b) new repair welded joint marked ZS2 in the primary steam pipeline specimens

The impact energy of the weld material and the parent material in the as-received condition, measured on V-notched impact-test specimens at room temperature, significantly exceeds the minimum expected value of 27 J. Also, the brittle fracture appearance transition temperature of the weld material runs at a level of approx. -30°C and -35°C for the joints marked ZS1 and ZS2, respectively (Fig. 4). The results of investigations on these features that characterise the formability should be considered satisfactory. However, it should be noted that with the increase in exhaustion degree the brittle fracture appearance transition temperature offset to a higher value is observed.

As the brittle fracture appearance transition temperature of the parent material after service for both the repair welded joints is positive, it is essential to observe the required conditions for starting up and shutting down the boiler.

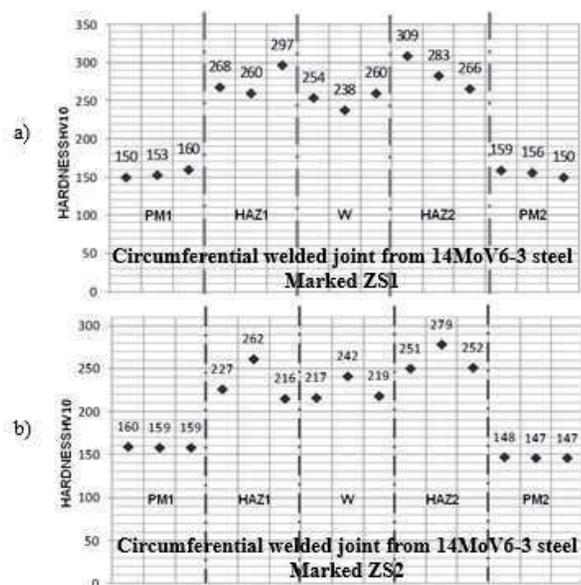
Fig. 5. Results of hardness measurement for: a) new repair welded joint from 14MoV6 steel after service marked ZS1; b) new repair welded joint from 14MoV6 steel after service and in the as-received condition marked ZS2

Also, hardness of the examined elements of new repair welded joints is much lower than the maximum permissible one equal to 350 HV. In both cases, mild changes in hardness during the transition from the parent material through the heat affected zone to the weld metal were revealed (Fig. 5, Table 2).

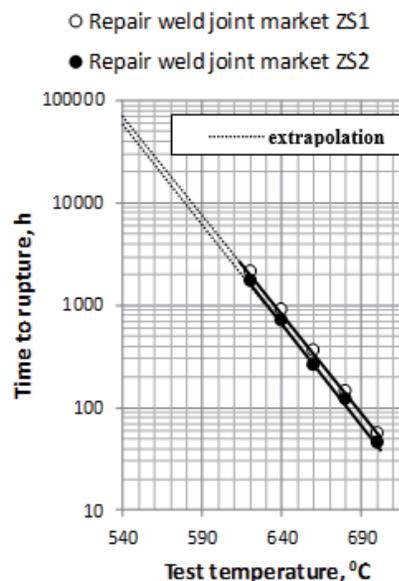
Fig. 6. Results of abridged creep tests of the repair circumferential welded joints marked ZS1; ZS2 as the relationship $\log t_{re} = f(T_b)$ at $\sigma_b = 55$ MPa

The residual life t_{re} determined for the repair welded joint of the materials after service, marked ZS1, is 80 thousand hours and the determined disposable life t_b is 48 thousand hours (Fig. 6, Table 4), while the residual life t_{re} determined for the repair welded joint of the material after service and the material in the as-received condition, marked ZS2, is 60 thousand hours and the determined disposable life is 36 thousand hours (Fig. 6, Table 4).

The time of safe service of the examined new repair welded joints can be assumed to be 48 thousand hours for the ZS1 joint and 36 thousand hours for the ZS2 joint.
