The evaluation of suitability for operation of repair low-alloy steel welded joints

Purpose: The purpose of the work was to evaluate the material condition of repair welded joints of steam pipelines with regard to their suitability for operation including determination of the time of their further safe operation.

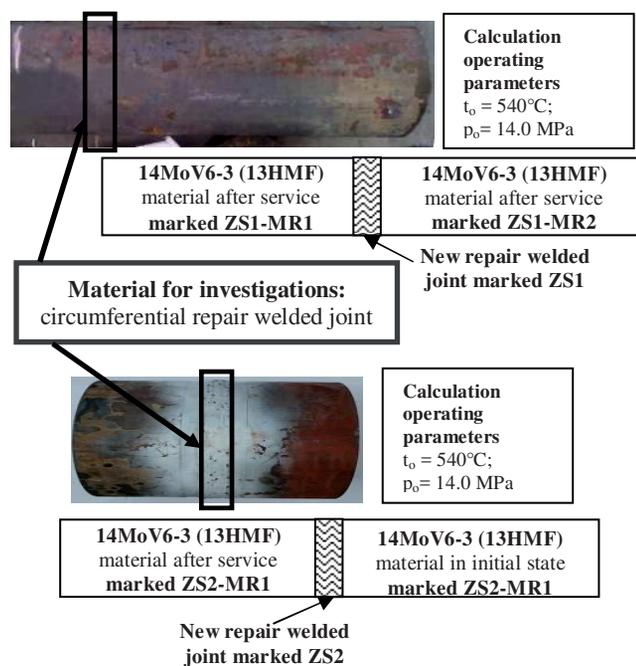
Fig. 1. Material for investigations in the form of new repair welded joints of: a) 14MoV6-3 steel primary steam pipeline (marked ZS1); b) 14MoV6 steel steam pipeline (marked ZS2)
