Stiffness behavior of hybrid laminated composites with surface crack

A. Güneş *, Ö.A. Şahin

Department of Mechanical Engineering, Selçuk University, Konya, Turkey

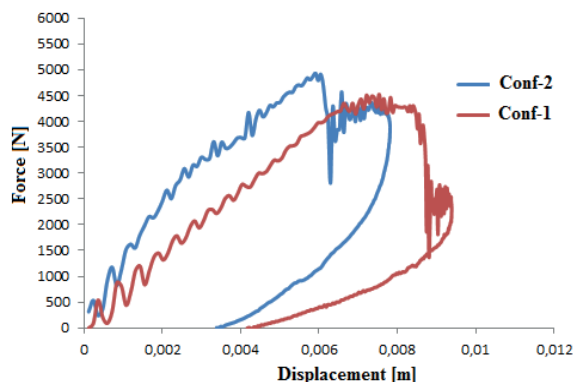
Fig. 3. Change of contact force versus displacement for different stacking sequences

The low velocity impact test results are given in Figures 2 and 3. Figure 2 shows the impact force-time behaviour for composite laminates subjected to different stacking sequences. Figure 3 shows that the impact force-displacement behaviour for composite laminates with different stacking sequences. When the loading is started, force increases linearly with displacement and reaches to its maximum rate. After this point the unloading stages starts with representing nonlinear behaviour. The incline of the loading phase of force-displacement curve is described as bending stiffness under loading. In the instance of delamination, bending stiffness decreases fundamentally and shows itself as depress in incline of force-displacement line. A fibre breakage generally results in decrease in stiffness associated with decrease in contact force [3,8].

As seen in this figure, the composite plate starts to deformation with increasing load and the vertical displacement reaches its maximum when contact force reaches its maximum value. After reaching maximum force and deflection values, the deformation starts to decrease. However, if the material has permanently damaged, the deflection does not reach to zero. As stated before, damage starts with matrix cracking. After this stage, delamination has taken place and followed by fibre cracking on the back side of the composite plate due to tensile stresses as a result of bending.
